**SOILS AND FOUNDATION
REPORT NO. 03-08**

**PROJECT PRA-FOOT 8G14
LANDSLIDE REPAIR**

**FOOTHILLS PARKWAY
GREAT SMOKY MOUNTAINS NATIONAL PARK
BLOUNT COUNTY, TENNESSEE**

April 2008

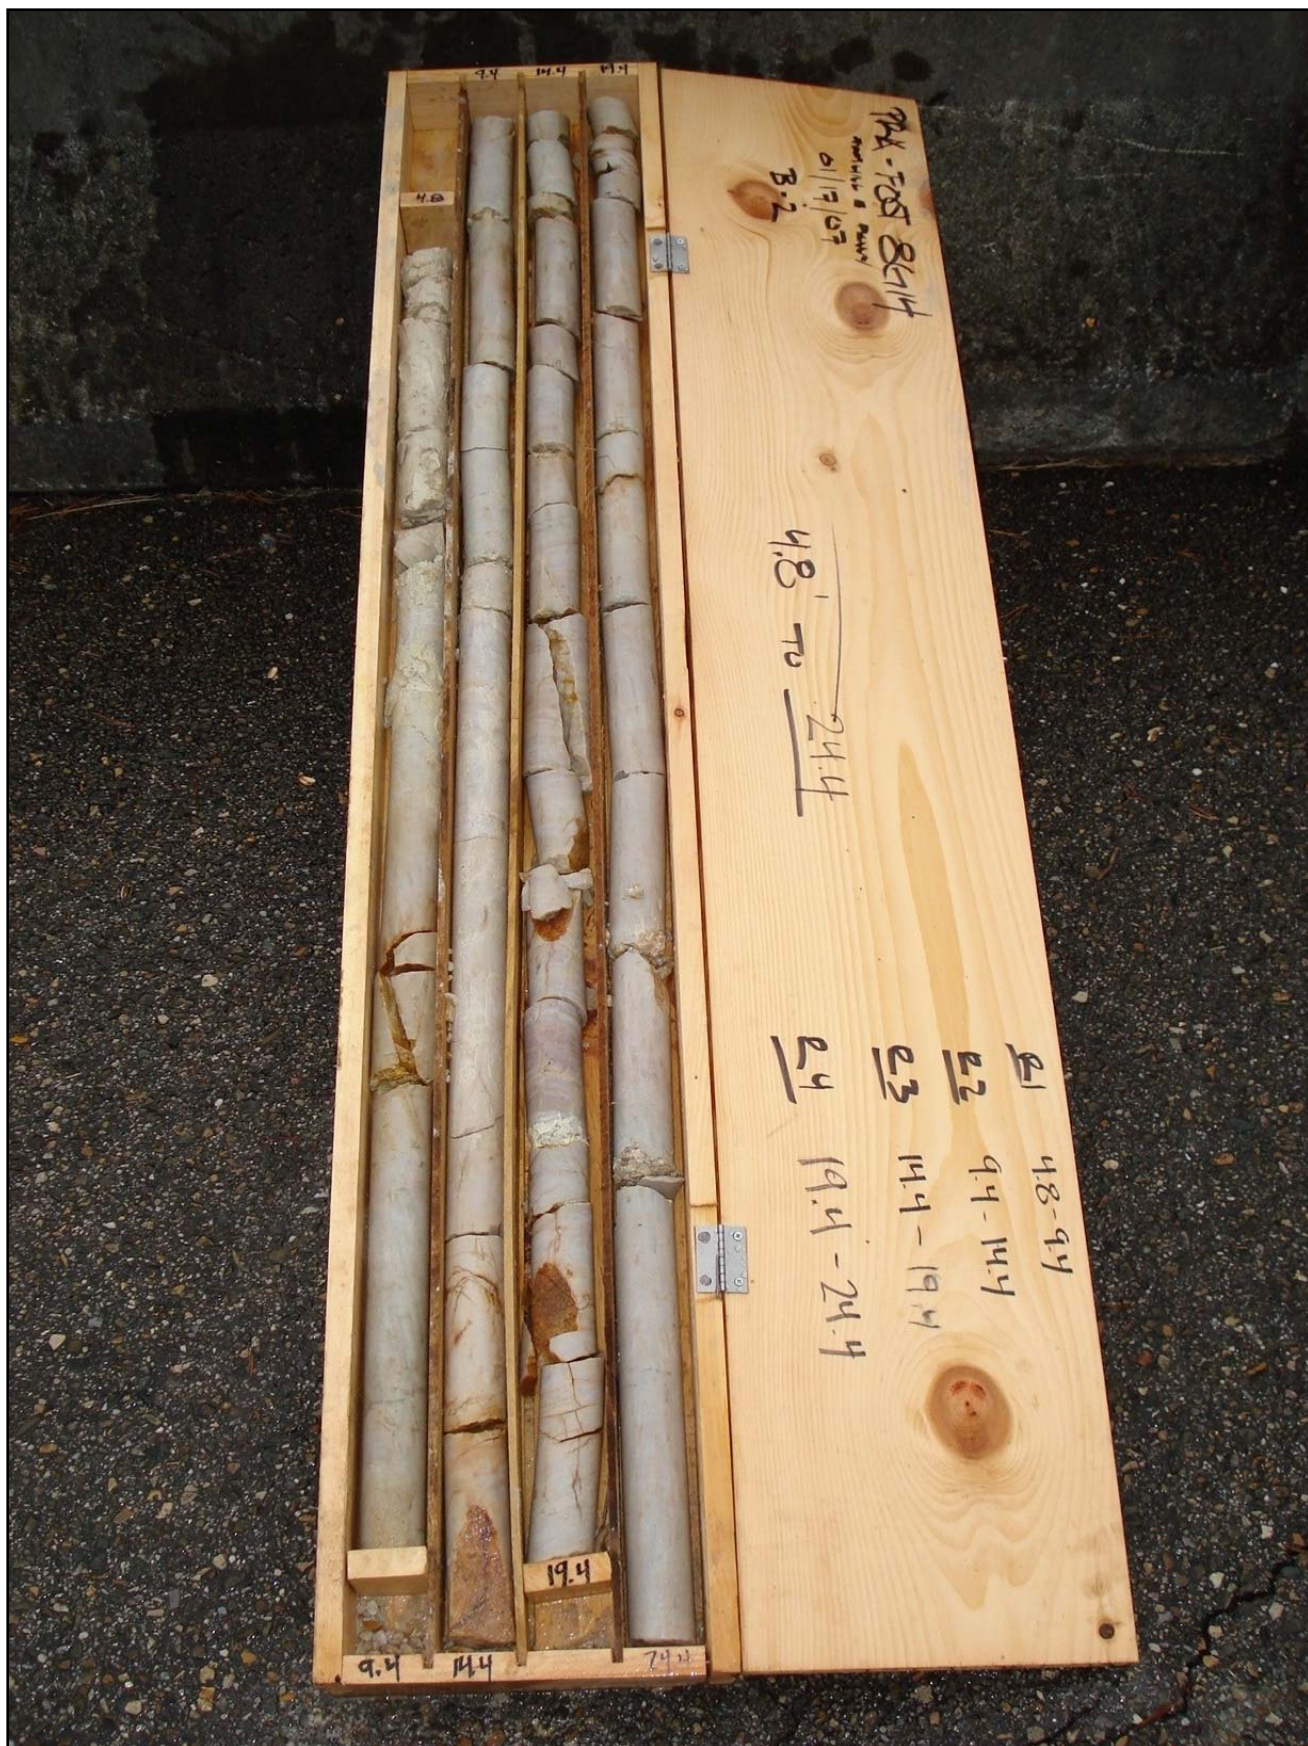
Photo No. 6 – Boring B-2 Rock Core

Rock – Intact bedrock was encountered underlying the decomposed rock strata at depths varying between 2.2 and 3.2 feet below ground surface. This strata is characterized by very hard, gray-brown to red-gray, relatively sound to sound, weathered to unweathered quartzose sandstone (arkose). Rock core recoveries ranged from 96 to 100 percent, and RQD values ranged from 80 to 94 percent, indicating good to excellent rock quality.
